Comparison of Cores from the Siljan and Ames Craters

Richard R. Donofrio, EDGe Research Associate, March 2003

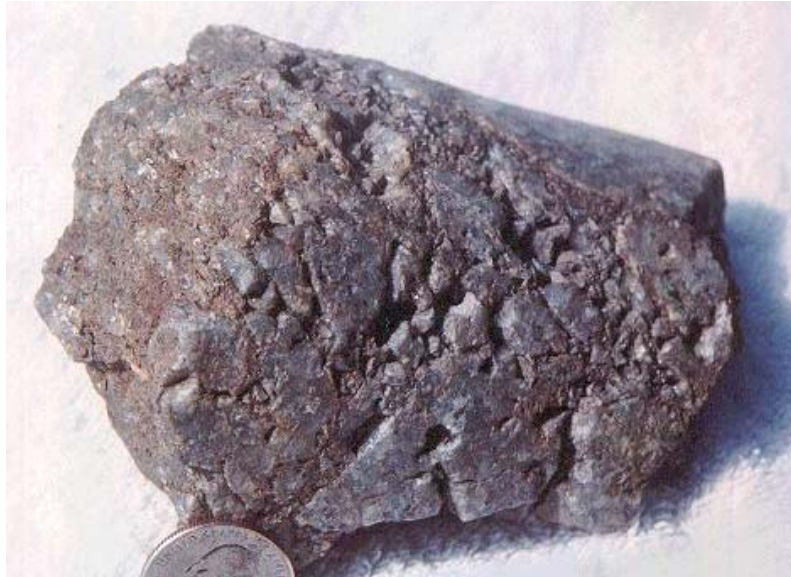
AMES – exceptional reservoir

The above photos show the striking differences in cores from the Ames and Siljan impact craters. Both structures are confirmed complex-type impact craters, and both cores were taken in the central uplifts, albeit off center. Both impact events fractured and uplifted granitic basement rock. Siljan is ~30% quartz, 50% orthoclase (hence the pink color), and 15% plagioclase; Ames is ~30% quartz, 10% orthoclase, and 50% plagioclase (hence the gray color). Minor amounts of other minerals are also present in the granites.

Ames was mildly eroded prior to burial. The reservoir is lithified granite (breccia) having porosities over 25% and permeabilities in the darcy range. Whatever hydrothermal effects may have been present is not a factor because the central uplift rocks were eroded to rubble, buried, compacted, and preserved. This reservoir is analogous to talus on the side of an eroded hill or mountain. It now lies beneath almost 2,700 m of overburden. The Ames core was cut just below this sedimentary–granite interface.

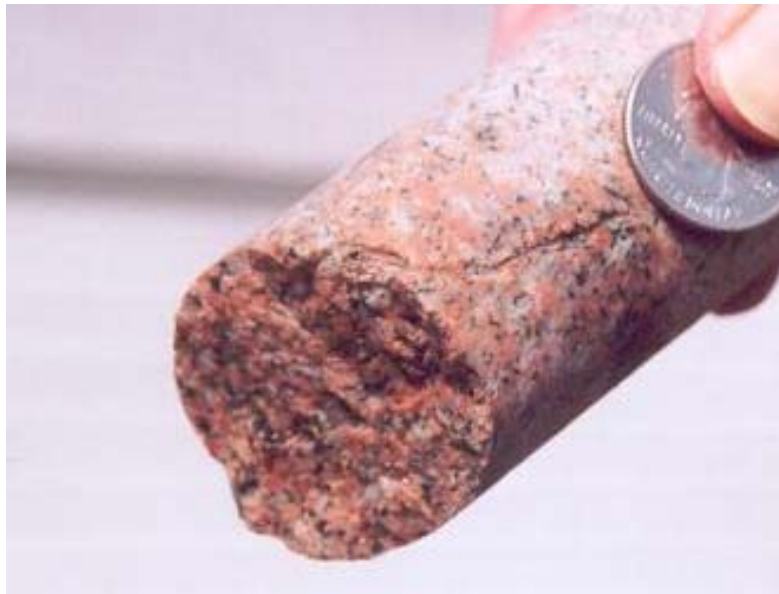
SILJAN – no reservoir

The profile of Siljan suggests that up to 1.5 km of the crater was downcut, exposing the substructure (rubble was largely removed by glaciation). The granite in the substructure has porosities ranging from <1 to 5% with permeabilities in the millidarcy range (≤ 0.1 md). Although this granite contains abundant fractures, most have been sealed by minerals deposited during post-impact hydrothermal activity and (later) by percolating surface/ground waters. One of these sealed fractures is evident in the core photo. Without open and interconnected fractures this rock cannot function as a commercial hydrocarbon reservoir. This particular core was taken at a depth of 459 m during continuous coring operations at Siljan in 1984. It is from one of seven test core holes and shows the typical reservoir properties, save for small weathered intervals of surface-exposed granite. No improvements in natural reservoir quality were later noted at Siljan either in cores, drill-stem tests or pump/leak-off tests to depths of >6,000 m.
